Mass Properties Measurement Errors Which Could Have Been Easily Avoided

Richard Boynton, President
Space Electronics, Inc.
81 Fuller Way
Berlin, Connecticut 06037
(860) 829-0001

For presentation at the
58th Annual Conference
of the
Society of Allied Weight Engineers

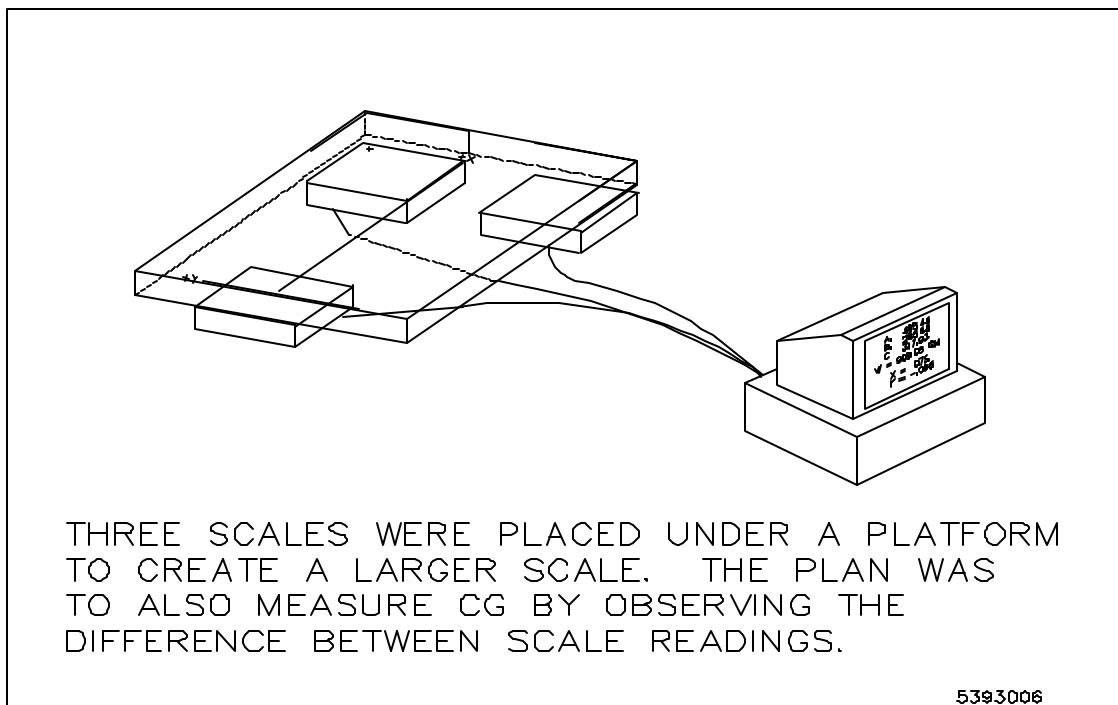
The first step in identifying the problem was to have the three scales calibrated. They were sent to the lab, and they all were shown to have errors which were less than 0.05%, yet the sum of the three readings had varied by more than 1%!

The second step in identifying the problem was to re-assemble the platform and place large test weights on it. The readings changed when the weights were moved. In addition, the total measured weight was larger than it should be. What was wrong??

{Answer}: Scales are not made to be linked together. In order to get accurate readings, a scale must float freely and not have any side load. Some scales are more sensitive to this problem than others. In this particular case there was another problem: the thin platform was bending under the weight of the vehicle, so that it was not square with the top of the scale, and presented a different side load when the vehicle was moved from one position to another. **(See Appendix for more information).**

Lesson learned: Scales cannot be linked together. They are only accurate when operated independently.

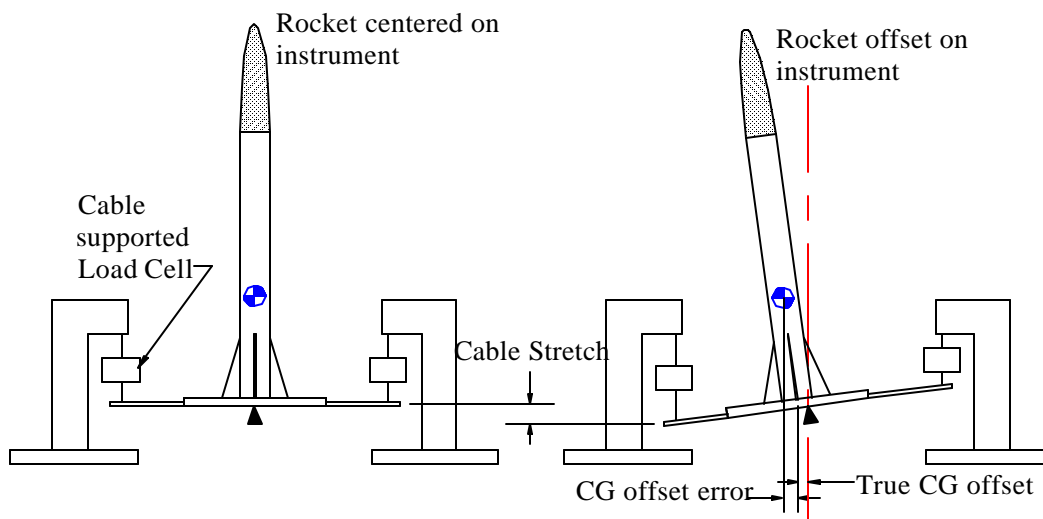
Cable stretch causes the Rocket CG to lean outward, increasing CG offset.

{Answer}: The cables were stretching, causing the vehicle to lean. Since the vehicle cg was considerably above the platform, the cg would move outward when the cable stretched, amplifying the cg offset. This was determined by placing a level on the platform, and then moving the vehicle to a new position.

Lesson learned: Multiple-point cg measurements require a rigid force measurement system. Otherwise, the cg of the object will lean outward, amplifying the cg offset.

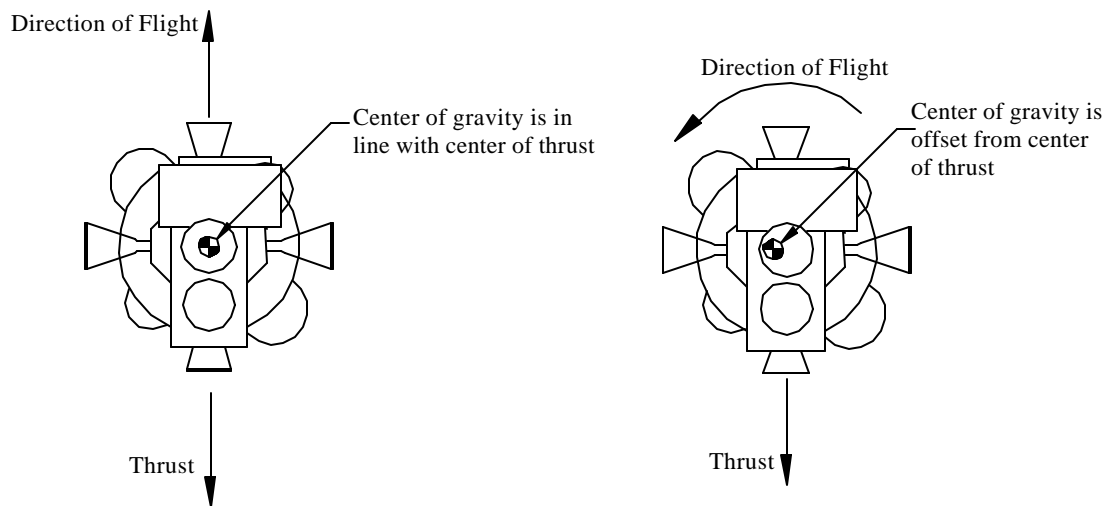
CASE #3 The Levitating Satellite which Turned Cartwheels It is essential that the center of gravity of a satellite be exactly in line with the centerline of the thrusters. Otherwise, when the thruster is fired, a torque will be created which causes the satellite to spin rather than translate its position. In this particular tragic case, a satellite test platform had been constructed to demonstrate the operation of a new control concept. In this experiment, the test satellite was to be dropped above a net, and the thrusters were to be fired while the satellite was in midair. It was expected that the satellite would be suspended in air and could be maneuvered above the net for a number of seconds. High level government personnel were present to witness the test. The day prior to making the test, the center of gravity had been measured and correction weights were added to move the CG to the exact centerline. Unfortunately, no one thought to re-measure the cg after the weights had been added. They had been added to the wrong side, doubling the cg offset, rather than trimming it to zero. At the appointed moment, the high-speed video cameras were started, and the satellites was dropped. Instead of levitating above the net, it instantly went into a spin.

Lesson learned: Always re-measure a vehicle after weight correction has been performed to make sure that the correction was successful.

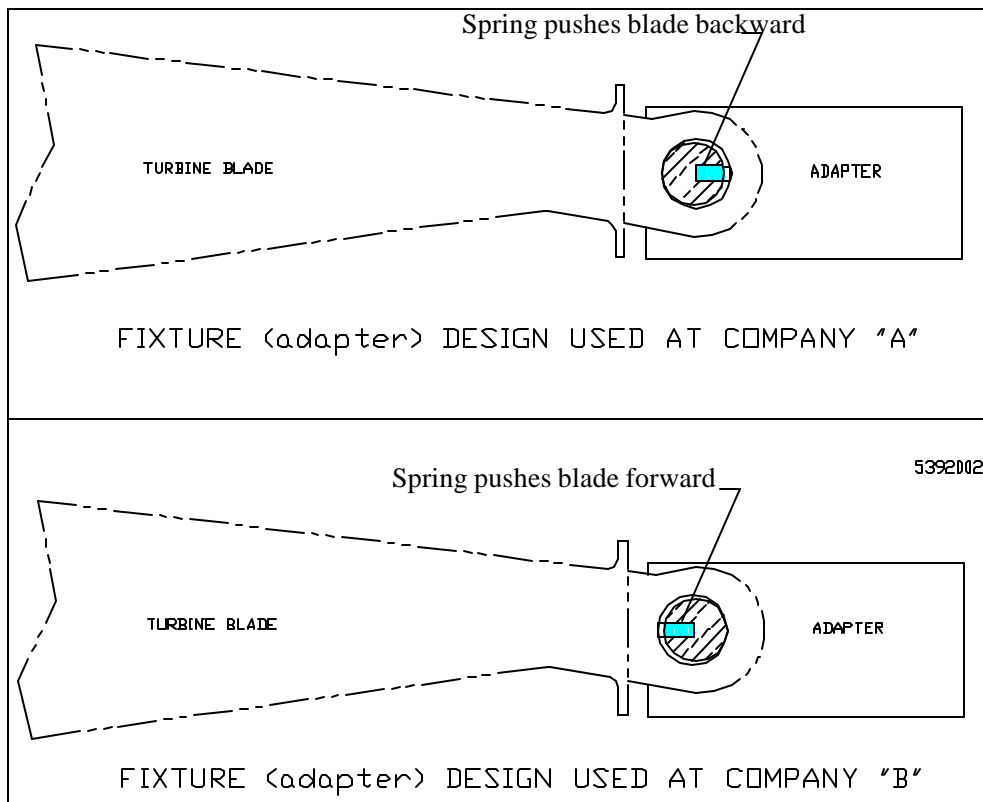
CASE #4 Turbine Blade Fixturing Error Two facilities were measuring the moment weight of the same type of blade. There was a consistent difference between the measurements made by the two facilities, so that blades measured by one could not be mixed with blades measured by the other when assembling the jet engine rotor. It turned out that the adapter had been assembled differently at the two facilities. At one location, the adapter spring caused the turbine blade to be forced forward. At the other facility, the adapter forced the blade backward. Which one was correct?

{Answer} Centrifugal force pulls the blade forward when it is spinning in the engine. Therefore, the blade should be forced forward in the adapter. The design used by company B is correct.

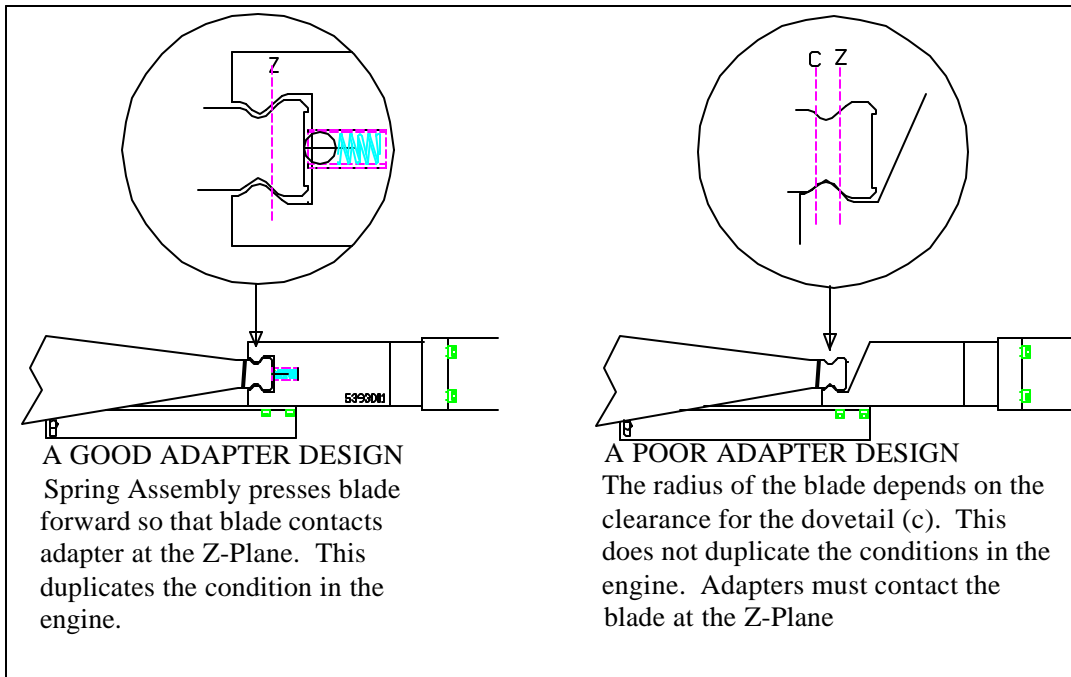
CASE #5 Another Turbine Blade Fixturing Error Turbine blades in a jet engine must be sorted by cg moment. Pairs of blades with identical moment are installed in the engine 180 degrees from each other, so that the unbalance is minimized. A jet engine manufacturer was sorting these blades with what he thought was a high precision, yet the engines were badly unbalanced after the blades were installed.

The problem was the point of contact of the blades with the adapter that was used in the moment measuring scale. In an engine, centrifugal force pulls the blades outward until the root of the blade contacts the hub of the engine. The engine manufacturer was contacting these blades at a different point during his static moment measurement.

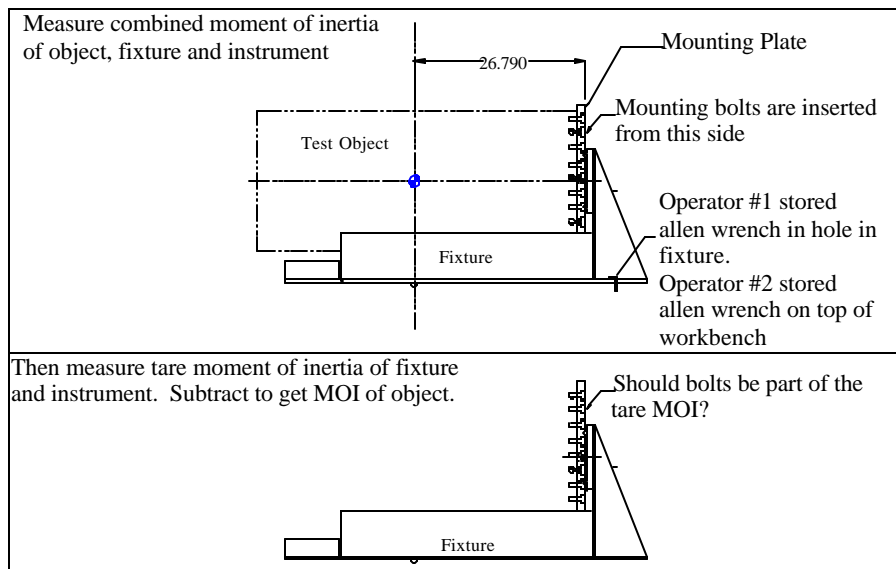
At first, it appeared that the problem had been solved. However, after the correct procedure was established for storing the Allen wrench, the cg data was still different between operator #1 and operator #2. What was going on? The illustration below of the configuration during tare measurement gives a clue to the answer:

{Answer}: Operator #2 included the mounting screws in the tare measurement, because he reasoned that these screws were not part of the object, and therefore should be left in place during tare measurement so their contribution to unbalance moment would be subtracted from the object measurement. Operator #1 left these screws out during tare measurement. Although operator #1 was careless about his location for the Allen wrench, he made the right decision about the mounting screws. These are installed during flight and therefore constitute part of the object.

Lesson learned: You must make a decision whether the mounting hardware is part of the object or unique to the fixturing method. If it is part of the object, then it should be removed during tare measurement. Don't leave any loose items such as wrenches on the fixture during measurement.

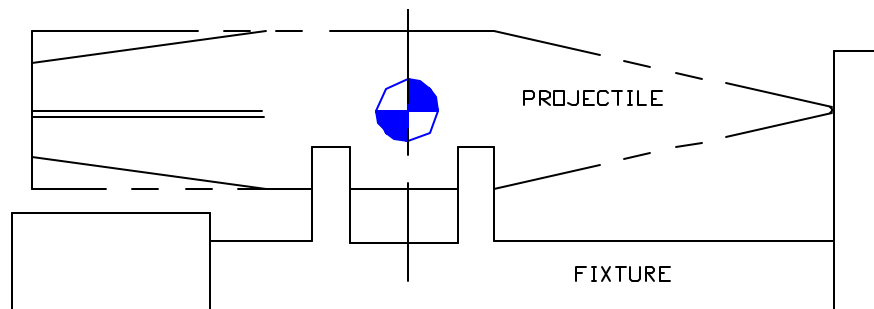
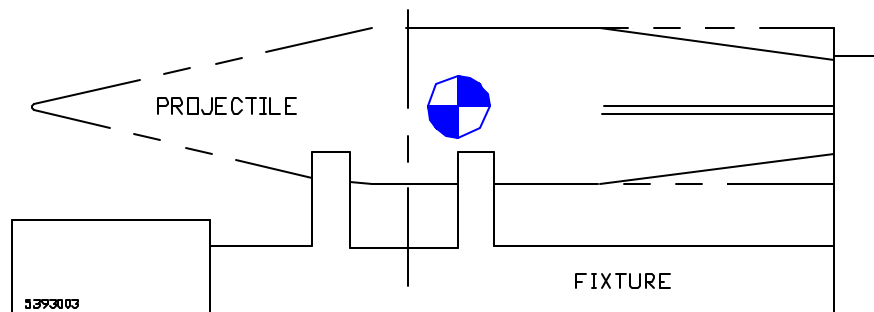
This fixture is designed to contact the nose of the projectile

If the projectile is placed in the fixture backwards, then all CG data will be in error.

(Answer): The nose of the projectile contacted the fixture end stop in measurement #1, whereas the aft end of the projectile contacted the fixture end stop in measurement #2. When the cg measurement specification was reviewed, it turned out that it did not define which end was the reference. Therefore, each measurement technician inserted the projectile in the direction that seemed logical to him.

Lesson learned: Measurement specifications must define the axes! Use the SAWE Recommended Practice #6 Standard Coordinate System whenever possible.

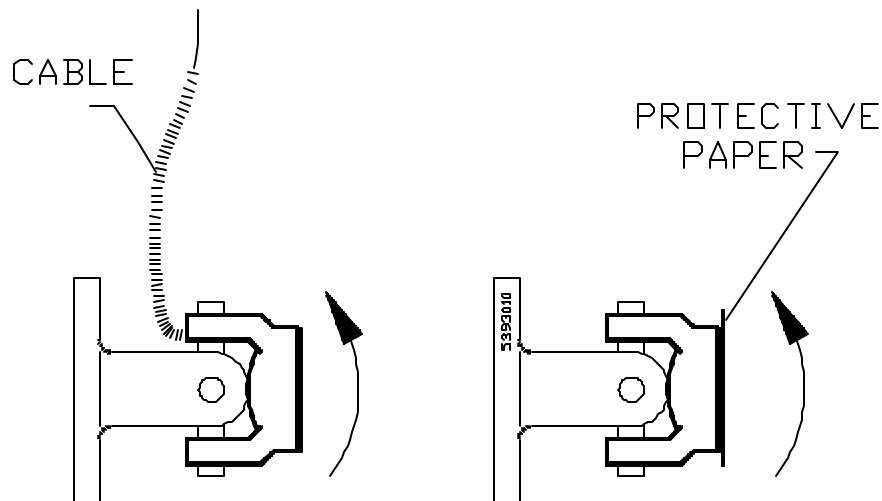
CASE #11 Protective Paper Used on the Face of a Gimballed Seeker Another company purchased a gimbal balance machine from Space Electronics for the measurement of a gimballed seeker. This seeker had a protective paper cover to prevent damage to the microwave antenna assembly. Balancing was performed with this paper in place. How much error could this paper have caused?

{Answer} Enough to make the seeker unbalance 10 times greater than the unbalance allowed.

Lesson learned on Case #11 and Case #12: Make certain that non-flight items are removed before weighing.

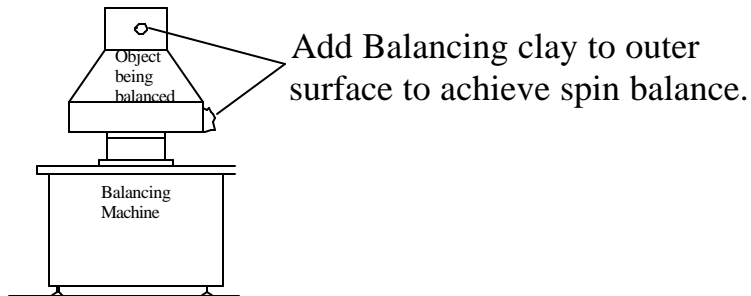
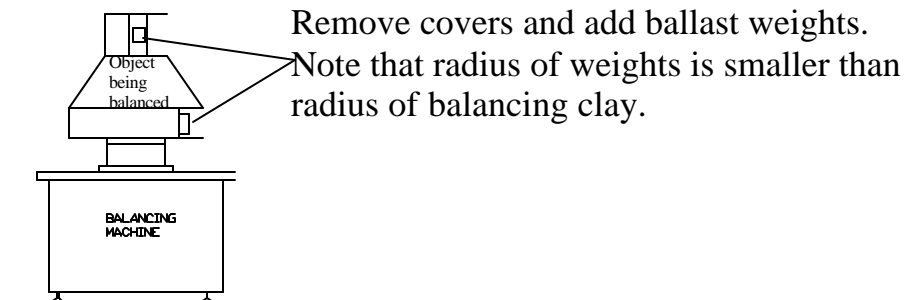
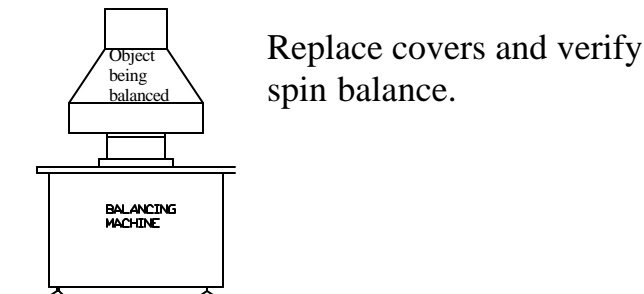
{Answer}: The radius of the balancing clay is greater than the radius at which the ballast weight are

installed. Unbalance is proportional to the moment RW , where R is the radius to the CG of the ballast weight (or the CG of the balancing clay). Let's say that the initial unbalance was 100 lb-in^2 . Normally you might expect the unbalance after correction to be about 3 lb-in^2 . However, if the radius to the CG of the balancing clay was 12 inches, and the radius to the CG of the ballast weight was 9 inches, then the unbalance after correction will be 25 lb-in^2 , rather than 3 lb-in^2 . To avoid this problem, you must increase the ballast weight by the ratio of the balancing clay Cg radius divided by the ballast CG radius.

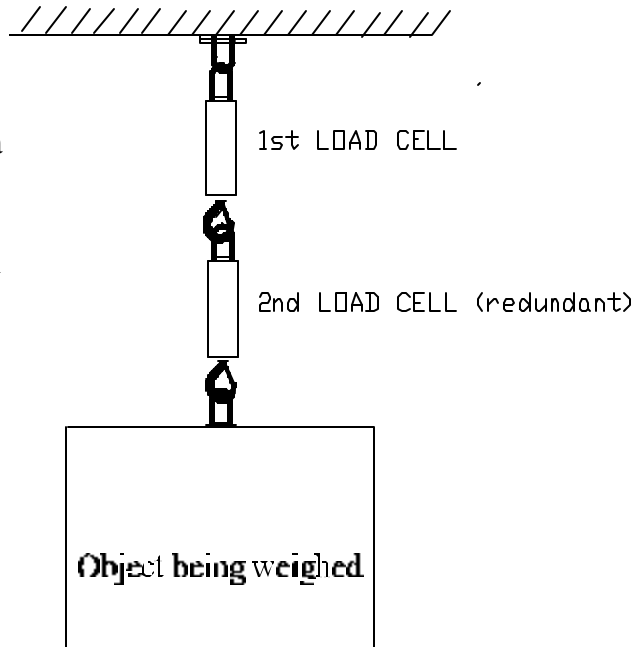
1. A common method of achieving redundancy is to put two load cells in series. Since each is measuring the same force, they should agree within a small percentage. One mass properties engineer sent a work order to have the weight of several large objects measured, using a crane hook scale. The mass properties engineer was not given authorization to witness the measurement. When the data was sent to him, the values were almost exactly twice what he had calculated. What was wrong?
{Answer}: The test technician had added the readings from both load cells to get the total weight.

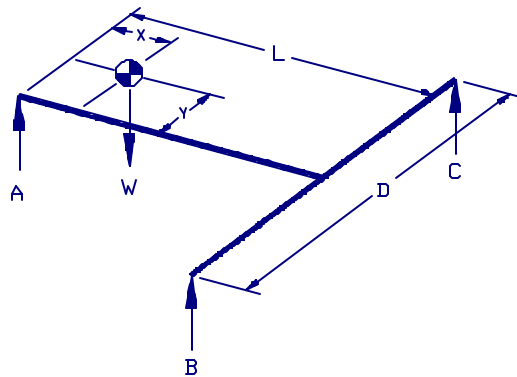
MULTIPLE POINT WEIGHING METHOD

To determine part weight (W) and CG coordinates X and Y, three force transducers are typically used to support a frame which in turn supports the test part.

The problem is that even a small error due to side load translates to a big CG error. Assume that

$$Y = 0.5 \times 60 \times 0.02 = 0.060 \text{ inch}$$
